Deliverable D2.5

**Reporting on implementation results from
MERLIN restoration case studies**

The MERLIN project (<https://project-merlin.eu>) has received funding from the European Union's Horizon 2020 research and innovation programme under grant agreement No 101036337.

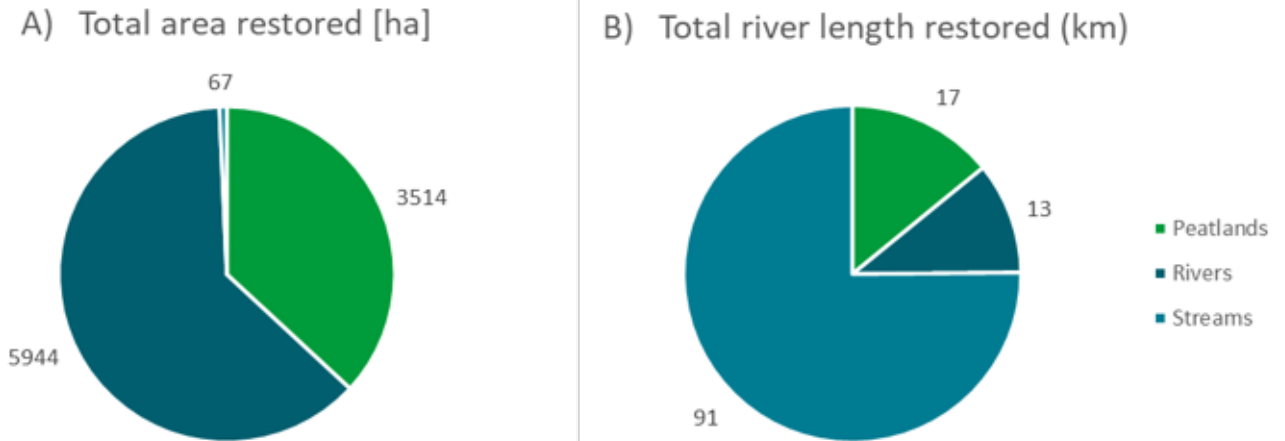
Figure 1: (A) Total restored area [ha] and (B) river length [km] within MERLIN. Pie charts show the distribution of restored units by the three clusters Peatlands and wetlands (green), Small streams and basins (petrol) and Large transboundary rivers (dark blue).

All 11 barrier removals and most restored river kilometres were achieved within the small streams cluster, while the large rivers cluster restored most of the land area, i.e. floodplains adjacent to the rivers (Figure 1).

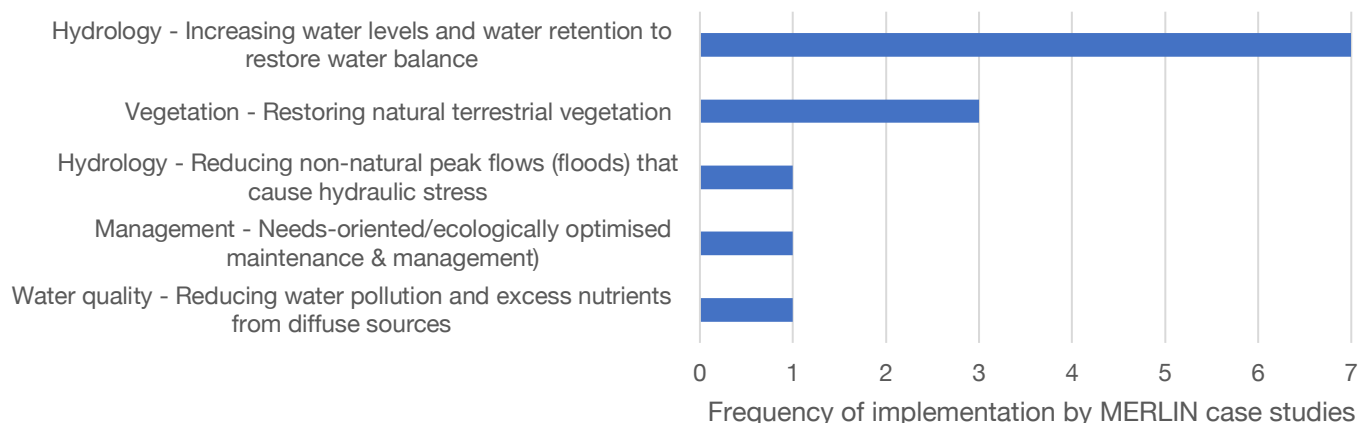
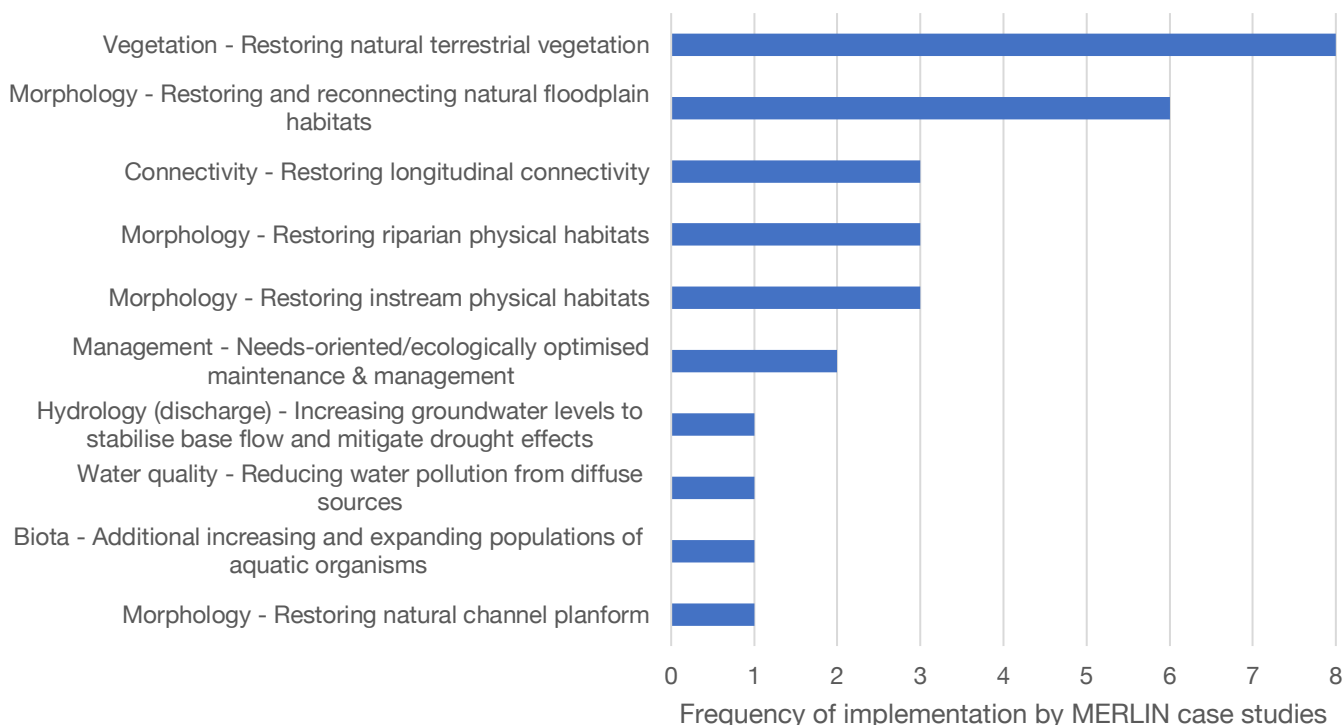
Figure 2: Restoration measures implemented within MERLIN distributed into measure types based on Birk et al. (2025). The typology separates measures performed in peatlands and other wetlands (A) from measures in streams or rivers (B). Note that case studies belonging to the peatlands and wetlands cluster in MERLIN can still perform "river and stream measures" of this typology, if they intervene in the local stream to restore the adjacent wetland.

The 16 MERLIN case studies implemented a total of 42 single restoration measures, from removing longitudinal or lateral barriers to adding leaky dams or woody debris to changing land-use to control of non-native invasive species. For comparability, these were sorted into categories (measure types, such as, "Morphology") and subtypes (such as "Morphology - Restoring riparian physical habitats") according to a typology suggested by Birk et al. (2025). The typology separates measures performed on or at streams and rivers from measures performed in peatlands and other wetlands. Within MERLIN, five different peatland and other wetland measure subtypes (in 13 single measures) and ten river and stream measure subtypes were implemented (in 29 single measures), covering changes to hydrology, morphology, water quality, connectivity, biota, vegetation and management (Figure 2). Even case studies belonging to the peatland and wetlands cluster in MERLIN performed "river and stream" measures where they intervened directly in the stream to restore their focal wetland area.

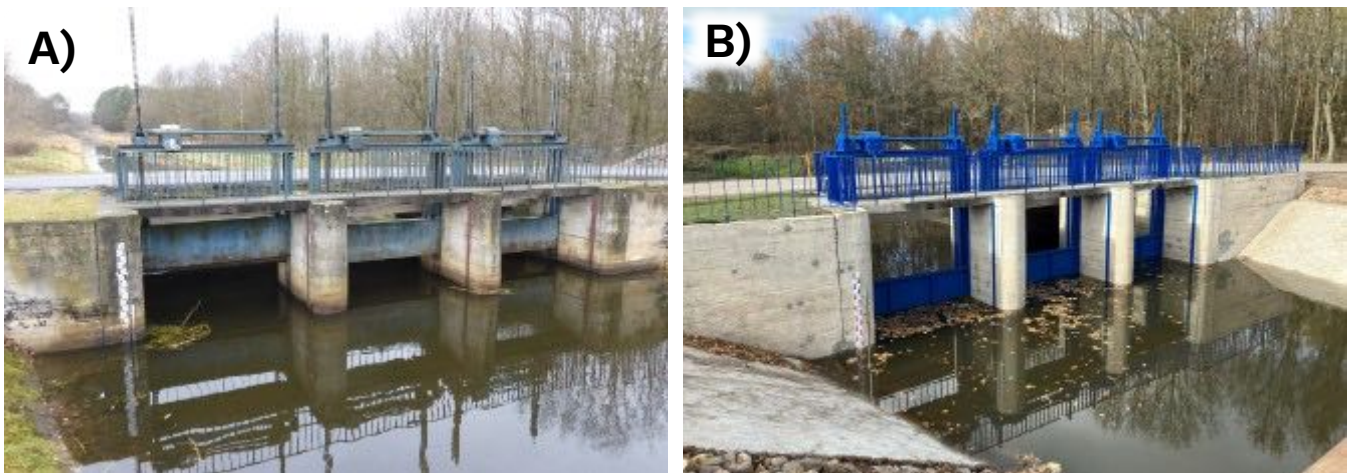
Figure 8: Before (A) and after (B) renovation of the weir at Zamość, Kampinos National Park (PL). This restoration helped re-wetting 198ha of peatland.

The second measure by CS05 was the renovation of two weirs responsible for the re-wetting of 6ha of peatlands. This was implemented as planned but the resulting re-wetted area was much larger than anticipated, covering 198ha.

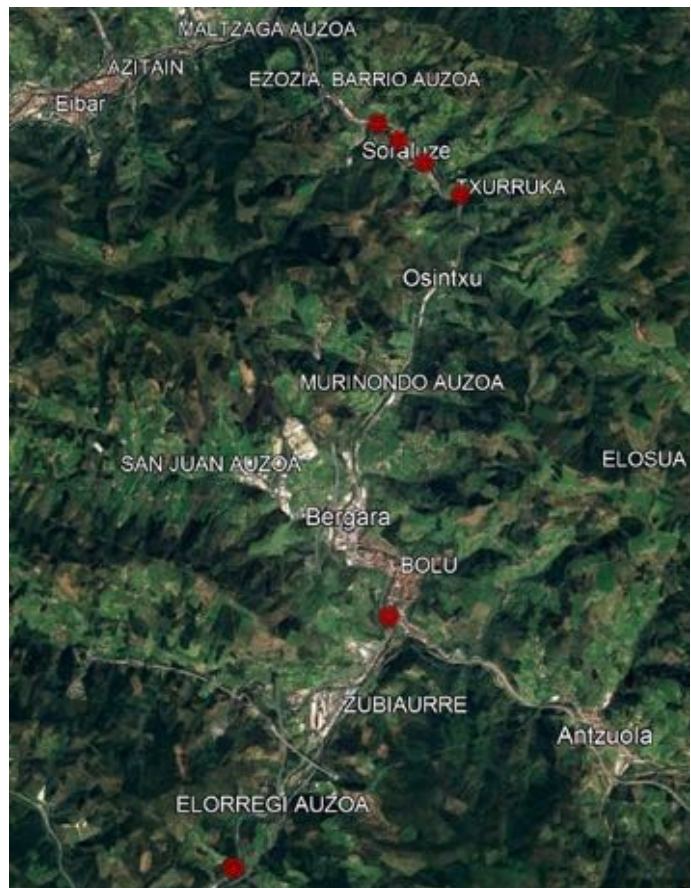
Figure 9: Location of six dams (red dots) removed in the Deba river, Spain.

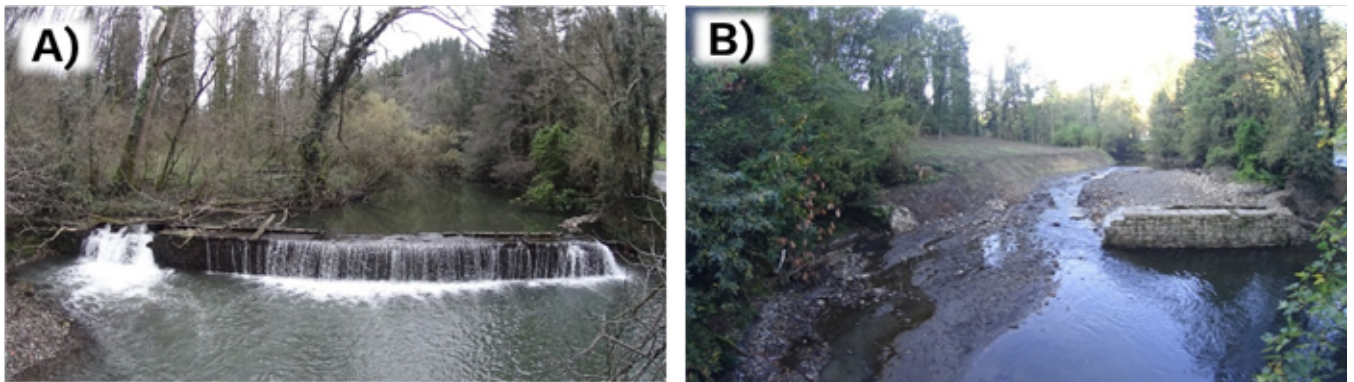
Figure 10: Before (A) and after (B) of the removal of one of 8 dams in the Deba river, Spain. This restoration helped restore 28km of free flow to the river.

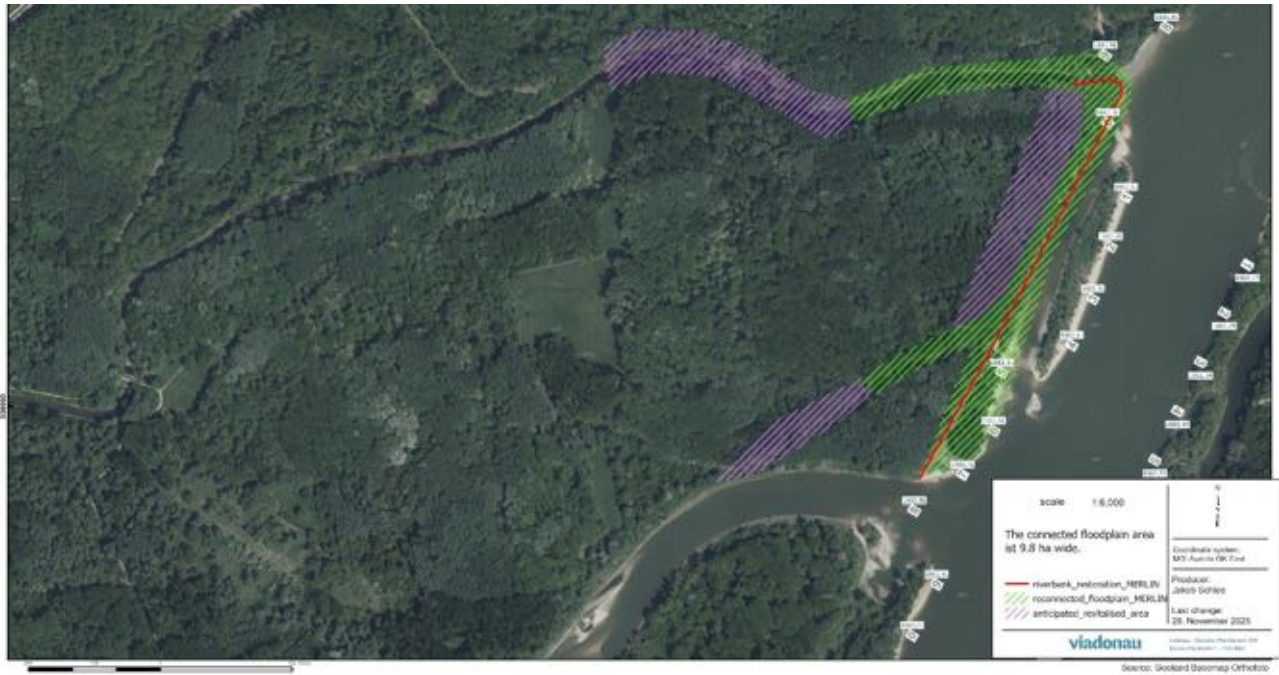
Figure 11: Map of the area of intervention of CS07a Danube floodplain restoration (AT).

Using integrative planning that takes into account both ecology and navigation, CS07a showed that riverbank restoration is possible on an international ferry way and that good ecological status and good navigation conditions are not necessarily contradictory. Located in the east of Vienna, this case study aimed at restoring a stretch of the Danube that is heavily regulated by embankments and groyne structures. Restoration in this area has been going on for 20 years and has focused on removing the rigid artificial watercourse to allow more natural hydrological dynamics and a widening of the river to protect the riverbed from depth erosion. The proposed restoration within MERLIN was to remove artificial embankments and transversal structures to re-connect a historical side-arm and to re-wet the adjacent floodplain.

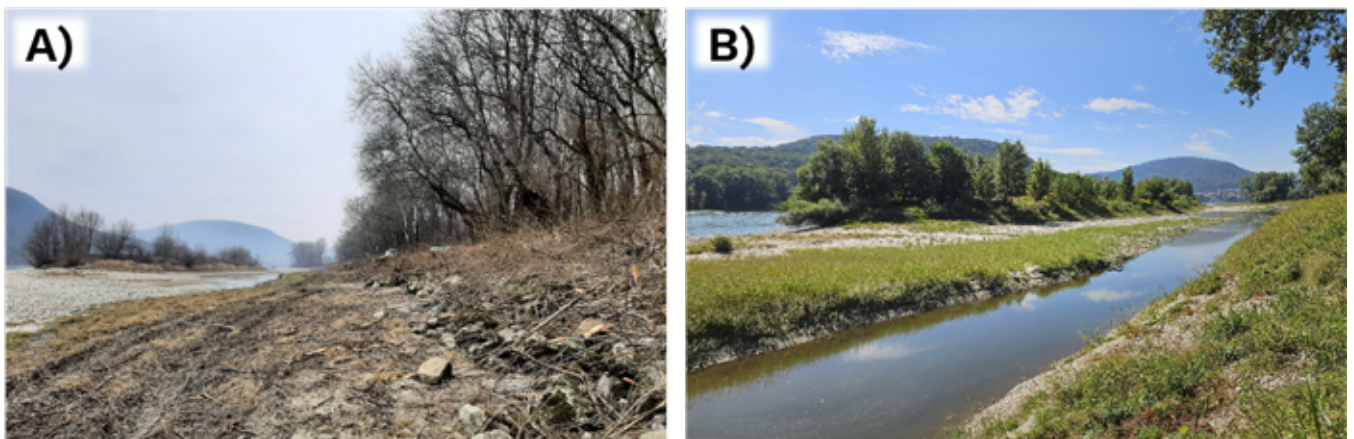
Figure 12: Before (A) and after (B) the removal of transversal structures to re-connect the Spittelauer Arm side-arm to the Danube, east of Vienna. This restoration helped restore natural river banks along 1km of the river and re-wetted 9.8ha of floodplain.
